RE: THE PASEO'S HOA - STRUCTURE CONFLICT ASSESSMENT

THE PASEO'S HOA
TREE VS. STRUCTURE
CONFLICT ASSESSMENT

December 5, 2016

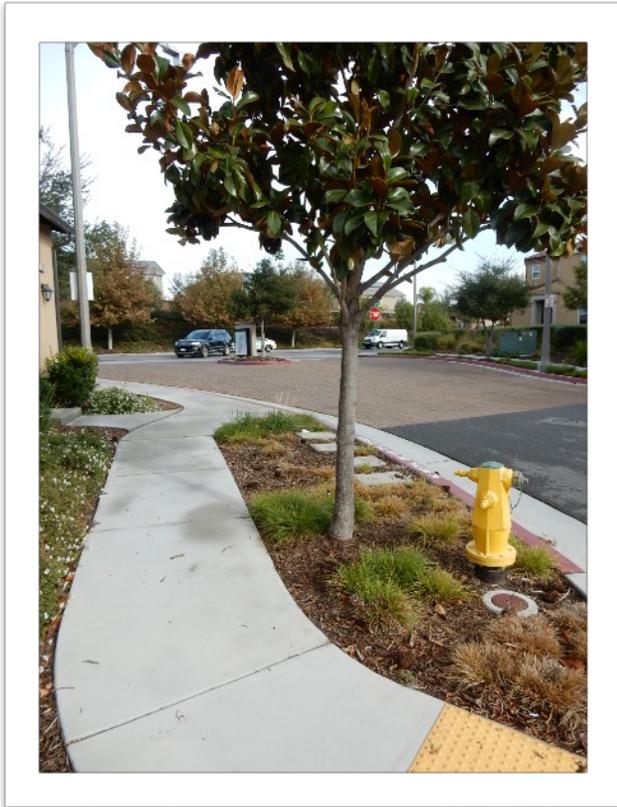
There were (68) different locations with trees consisting of multiple species that were planted too close to structures or hard-scape. Some locations had only one tree in conflict with structures and other locations had multiple trees in conflict (see Conflict Locations in Supporting Documents, Appendix B). The **drip line** area under the trees consisted of mulch and shrubs that were being irrigated with drip tubing and emitters (see Photos # 1-3 in Appendix A).

Photo # 1 - This photo shows understory plantings. This is consistent throughout the community.

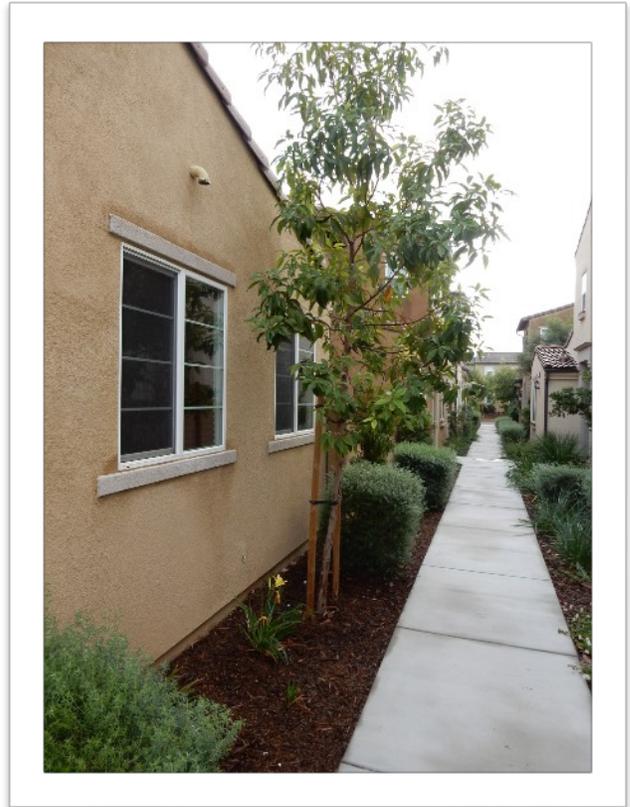
Photo # 2 - The shrub plantings are the appropriate choice for this application. The planters are too narrow for large trees.

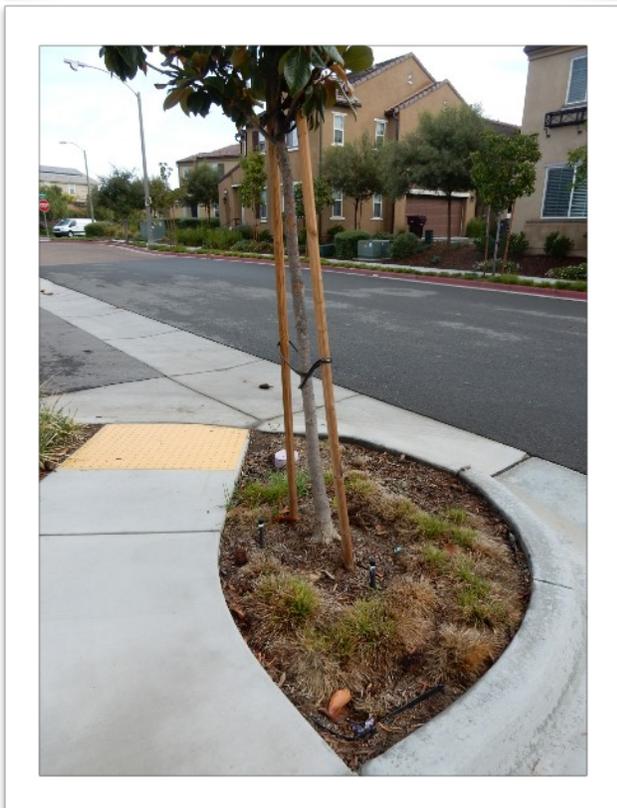
Photo # 3 - All areas are irrigated with bubblers, drip tubing or a combination of both.

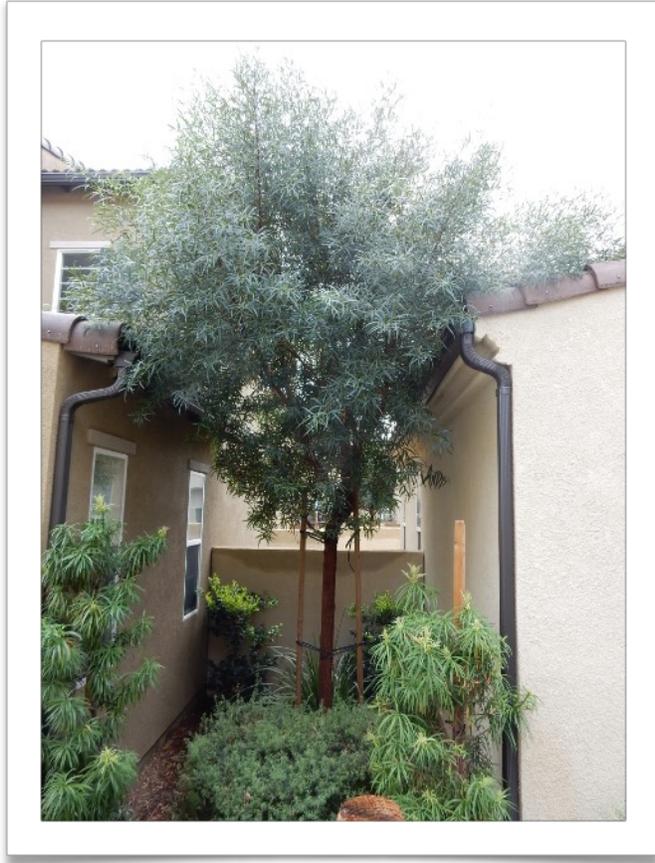
The structure conflict consisted of insufficient space for proper **crow**n development (see Photos # 4-7 in Appendix A). Many of the trees had been planted in planters too small to accommodate even a shrub (see Photo # 8 in Appendix A). Also, many trees were planted in areas that did not contain the minimum root space that would typically be recommended. We did note the use of **root barriers** (see Photo # 9 in Appendix A) and they may minimize, yet not prevent, any future hardscape conflict.

Photo # 4 - This African sumac is still on stakes and is in conflict with adjacent structures.

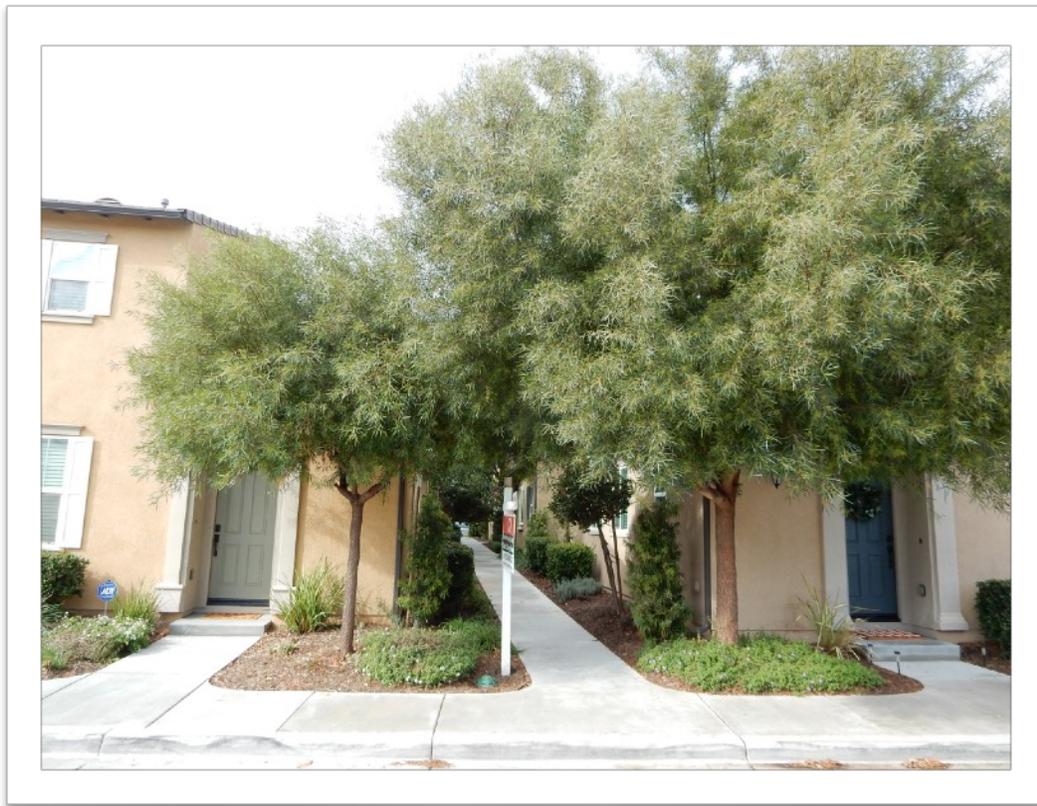
Photo # 5 - There are (2) African sumac flanking this walkway. This is preventing safe access to a living unit.

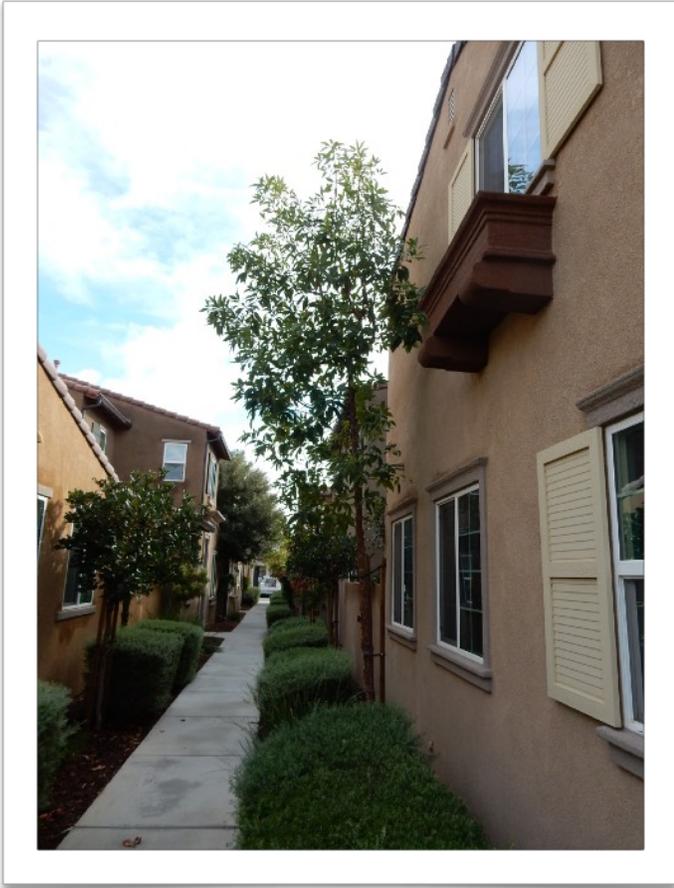
Photo # 6 - This Brisbane box is approximately 10” from the structure.

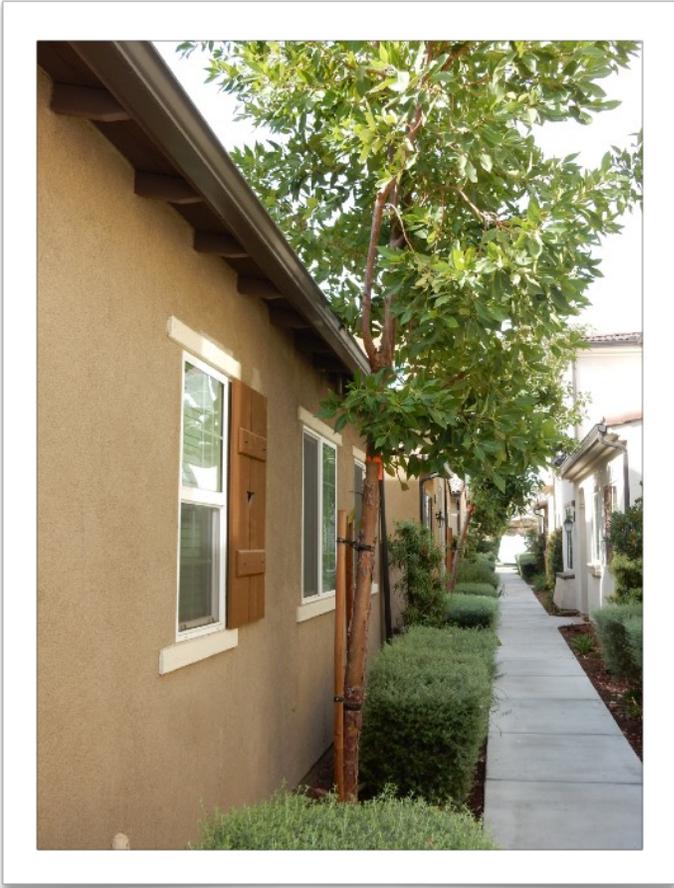
Photo # 7 - This Brisbane box is in conflict with overhang and rain gutters. It is still on its stakes.

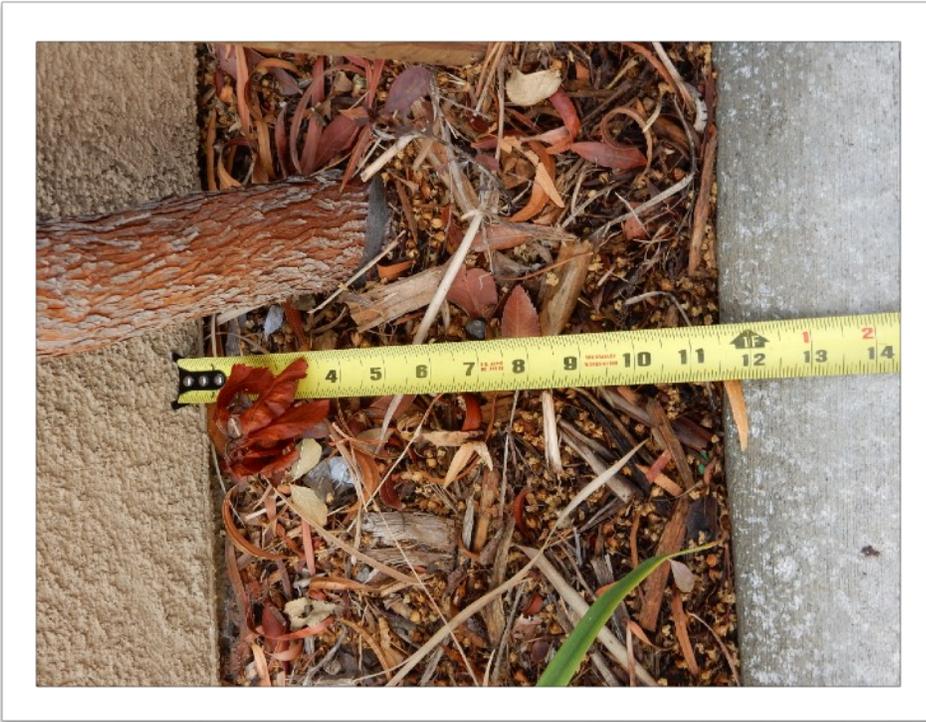
Photo # 8 - This strawberry tree was planted in a planter less than one foot wide. It was also planted against a wall. A planter this small may not even support a shrub.

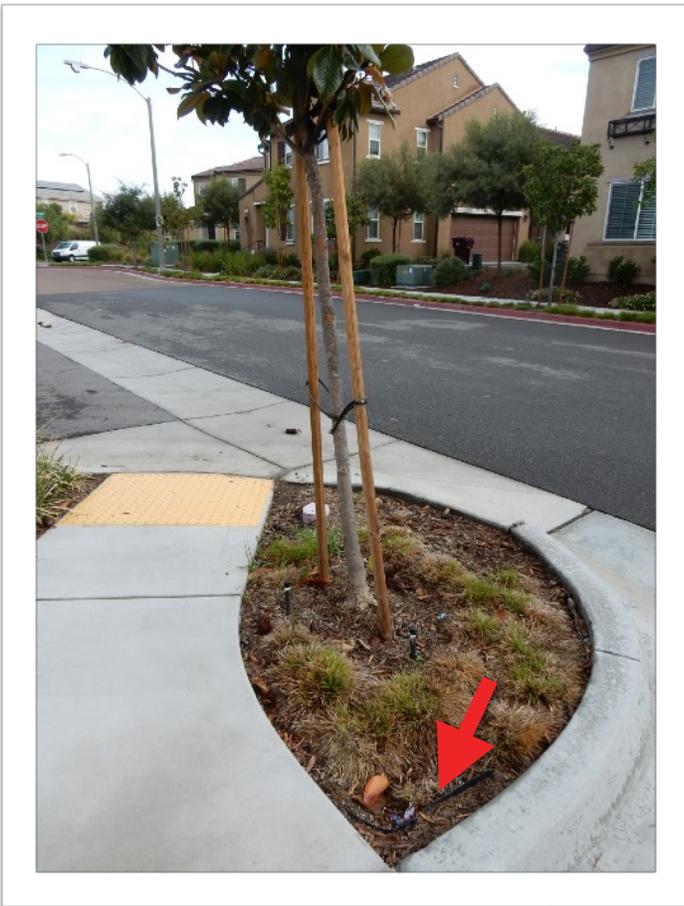
Photo # 9 - We did note use of root barrier (red arrow) in some locations. These will provide some protection, however, the limited spaces and root barriers will create long-term root defects.
